# **Preliminary Report 001/2015**

## **SERIOUS INCIDENT**

**Aircraft Type and Registration:** Boeing 777-3DZER, A7-BAC

**Location** Miami International Airport, USA

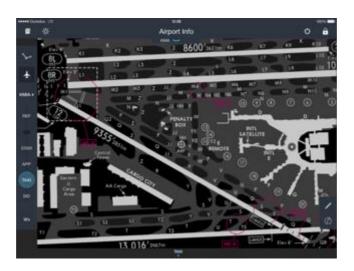
the airfield. He had the screen 'zoomed in', so he could clearly see the names of the taxiways as he passed them, although the scale selected, the size of his screen and the position of the chart, meant he was unable to see where he was in relation to the runway threshold. (Figure 2).

Figure 2 - Screen shot of airport information chart, as displayed on the commanders EFB

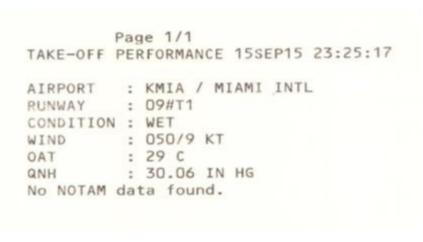
As they taxied along S the commander decided that the aircraft could depart from the runway intersection T1. He could not recall why he made that decision, but believed it may have been because the printed information displayed 'Runway 09#T1' in a compelling way. The printed information contained no reference to the fact intersection departures were not permissible from this runway (Figure 3), and contained the message 'No NOTAM data found'.

Figure 3 - Printout of the On-board Performance Tool data

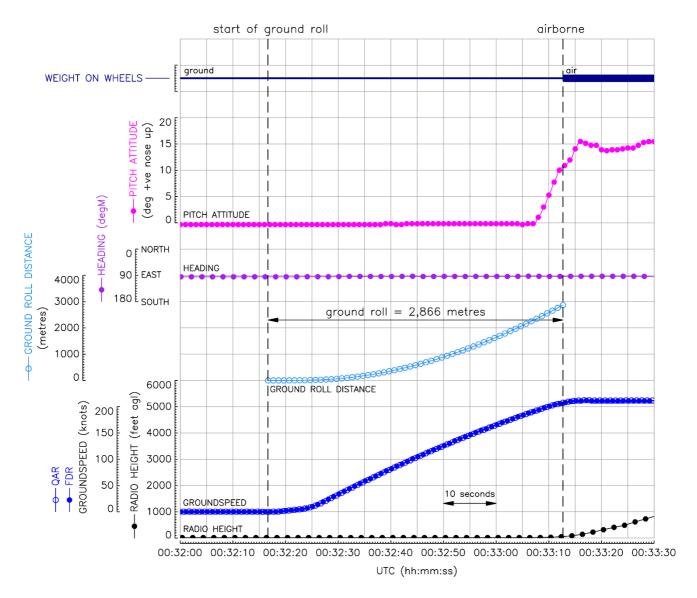
The Cockpit Voice Recorder (CVR), Flight Data Recorder (FDR) and Quick Access Recorder (QAR) were successfully downloaded. Figure 4 shows certain take off parameters as well as a calculation of ground roll distance (from the groundspeed recorded on the QAR).

Figure 4 – Take-off data

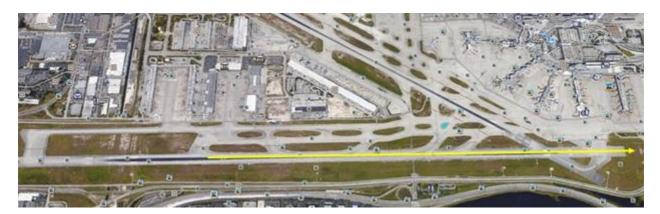
The recorded data indicates the ground roll was approximately 2,866m long and that the aircraft was still on the ground as it left the runway (Figure 5). Airport security cameras recorded the aircraft then coming into contact with some of the approach lights for Runway 27.

Figure 5 - Yellow line indicates the aircraft senses it is on the ground

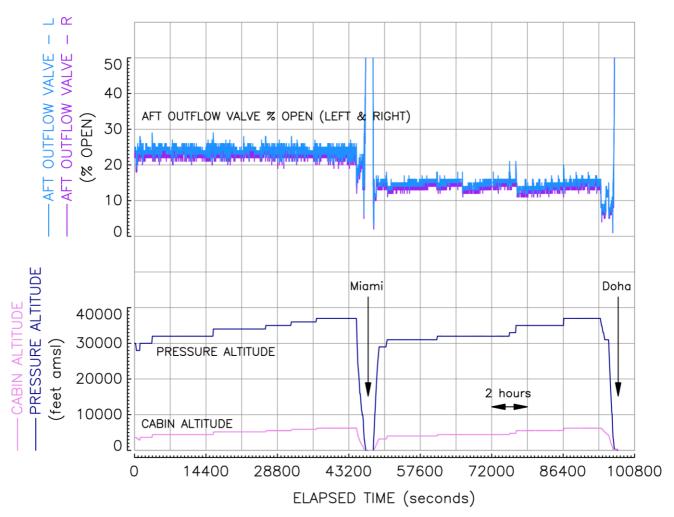
Figure 6 shows the position of the aft outflow valve<sup>1</sup> on the previous flight, and its position on the flight to Doha after the collision with the approach lights. It can be seen that the valve is more closed on the return flight compensating for what was found to be a puncture in the pressure vessel.

Figure 6 - Aft outflow valve position

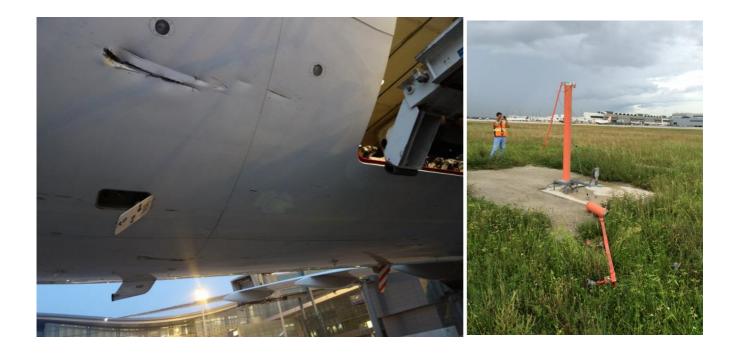
The damage to the aircraft comprised of a 46 cm tear in the fuselage behind the rear cargo door (Figure 7) which breached the pressure vessel. There were numerous dents and scratches in the external airframe with 18 square meters of damaged skin. There were 90 external individual areas of damage requiring assessment and rectification, there was also some damage to a metal guard on the left landing gear.

Figure 7 - Damage to the hull behind the rear cargo door and to an approach light

Damage was also found at Miami International airport to three of the Runway 27 approach lights.
